# PROPERTY INSPECTION REPORT FORM

11/13/2023

800 Emilia Ct., Austin, TX 78746

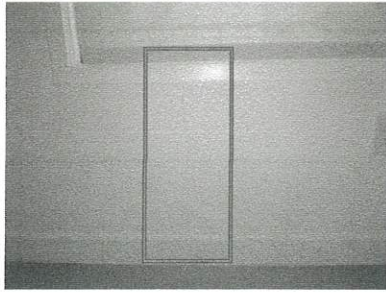
There is fracturing in the dining room wall drywall below the window.

Drywall is damaged above the fireplace in the living room.

There are tape joint and compression cracks at various interior wall and ceiling locations.

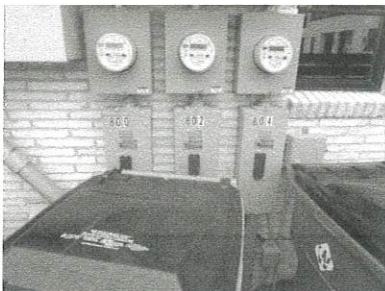
The exterior disconnects are located at the rear right of the building.

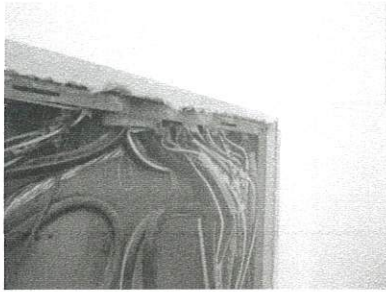
The panel is installed recessed from the face of the drywall.

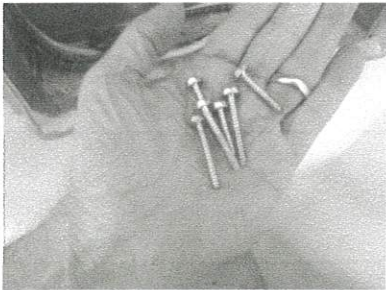
Manufacturer supplied OEM screws could not be used due to improper panel installation.

- The panel dead front cover is attached with sheet metal screw(s).
- Screws are in dangerously close proximity to conductor(s) inside the panel
- Damage to the conductor insulation will result in an electrical fault that could be potentially very hazardous.
- Replace the substandard screws with blunt tipped screws supplied by the manufacturer of the panel.
- Safety/Fire Hazard.

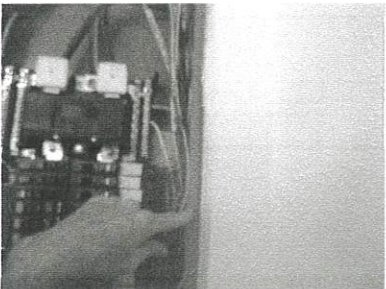
Drywall gaps around the panel are greater than the allowed 1/8". [NEC 312.4]

- Seal the gaps.

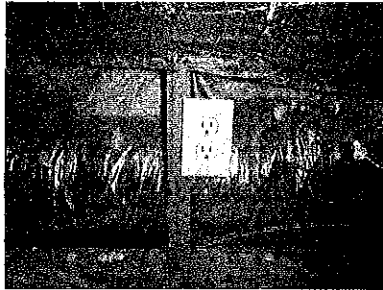
GFCI protection is missing at the mechanical system service receptacles in the attic. [NEC 210.8(E)]  
-Install GFCI protection where required.

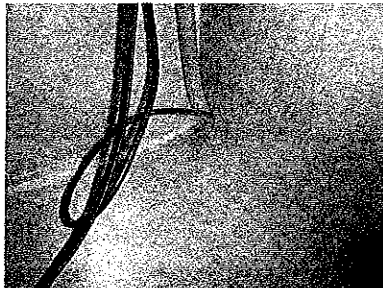
The dishwasher flexible electrical attachment cord lacks a required bushing or grommet at the cabinet penetration where required. (NEC 2020) [422.16(B)]

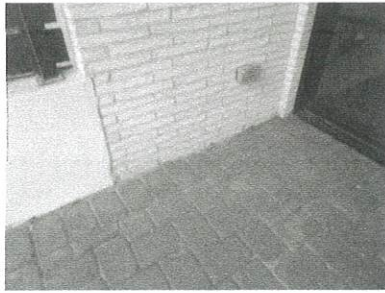
Grade is in contact with exterior cladding or lacks 4" of clearance to masonry walls or 6" of clearance to all other siding materials as required by [IRC R404.1.6]. This condition will permit water intrusion into the wall assembly, water damage to structural elements, and is considered to be a conducive condition for termite infestation.

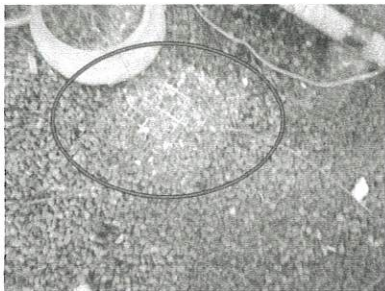
There are ground water drains at the perimeter of the structure. Performance and capacity are indeterminate. Keep clear and free flowing at all times to facilitate proper drainage.  
-The drain is completely blocked and will not drain properly.

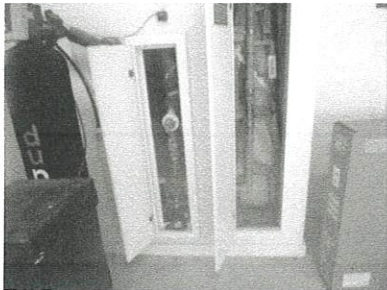
The interior garage wall enclosures are a breach in the required fire separation of the interior garage walls.

- Not less than 1/2-inch gypsum board or equivalent applied to the garage side of structural members supporting the floor/ceiling assemblies or garage ceiling. Structural members include, but are not limited to: walls, columns, beams, girders, and trusses.
- [IRC R302.6]
- The unsealed wood doors do not meet these requirements.

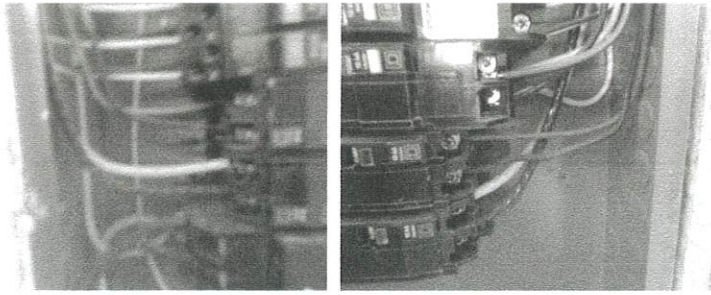
Breaker(s) have a "white" wire utilized as a "hot" conductor on one leg of the circuit without being designated as such. For example, this white wire should have a piece of red tape wrapped around it to designate it as a "hot" conductor versus a "neutral" conductor. [NEC 210.5]

Remove all foreign debris from the panel interior.

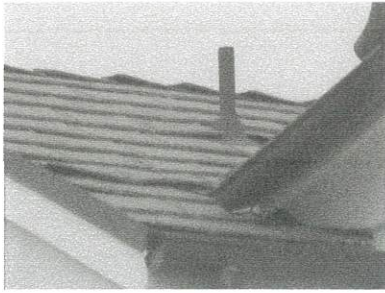
Plastic roofing tiles are not installed flush to the roof surface and may be subject to wind lift and storm damage.

-Gaps in the tiles may lead to water penetration and water damage.

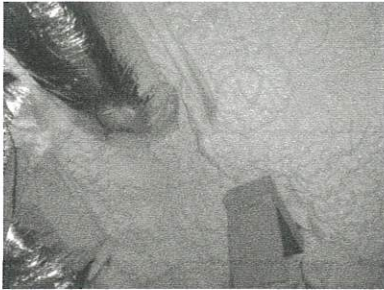
The attic(s) is insulated with spray foam that is applied to the underside of the roof decking. This is method of insulation encapsulates the attic space and HVAC systems in the thermal envelope of the structure and achieves a higher energy efficiency for the structure. One unique characteristic of this method is that the attics are not ventilated as in conventional construction. Since the roof structure, decking, and roof surface penetrations are not visible, it is unknown what, if any, deficiencies might exist.

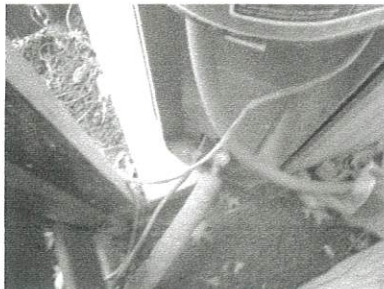
The thermostat control wiring is not properly protected from damage and contained within an approved raceway at the condensing unit.

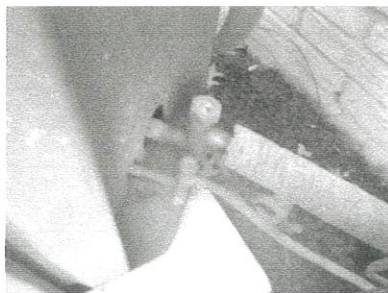
Required tamper proof refrigerant line valve caps are not present. [IRC M1419.9]

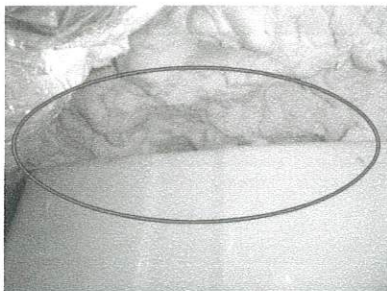
The top of the water heater lacks manufacturer required clearance for service and access to the exhaust vent and intake vent.

- The manufacturer requires a minimum of 9" Clearance.
- Current clearance is improper.
- Refer to Page 15 of the Installation Manual.

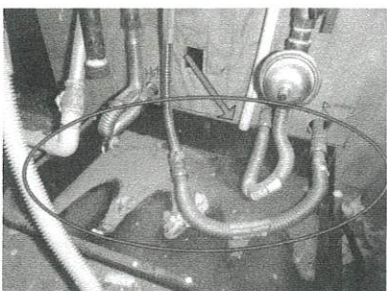
The condensate drain line is not plumbed to the exterior drain.

- Discharge into the drip pan is not draining and causing water to accumulate.
- The drain line is not plumbed to an exterior drain line as required by the manufacturer.
- Refer to Page 27 of the Installation Manual.

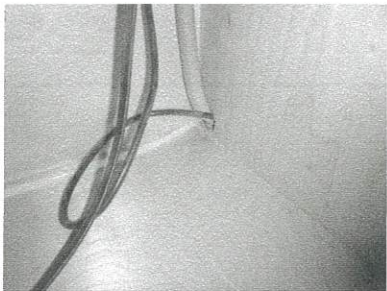
The dishwasher flexible electrical attachment cord lacks a required bushing or grommet at the cabinet penetration where required. (NEC 2020) [422.16(B)]
