# PROPERTY INSPECTION REPORT FORM

11/13/2023

800 Emilia Ct., Austin, TX 78746

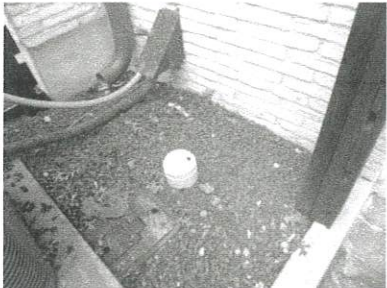
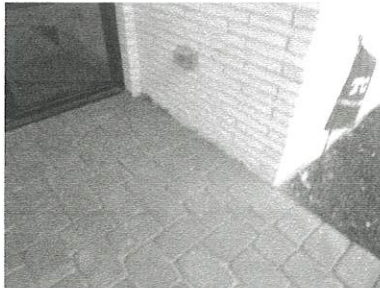
The foundation lacks the required height above finished grade. Foundations shall be a minimum 4" above grade where masonry veneer is used, and a minimum 6" above grade for all other wall materials. This condition is often a contributing factor to water penetration of the structure and should be corrected ASAP. (IRC R404.1.6)

Spalling observed along brick ledge and/or at corners of foundation beam. Cracks of this type are the result of friction between exterior cladding and foundation as a result of differential thermal expansion and contraction rates of dissimilar materials and does not represent a loss of structural integrity and are cosmetic in nature unless otherwise noted. Cracks should be monitored and perform repairs in the future as necessary.

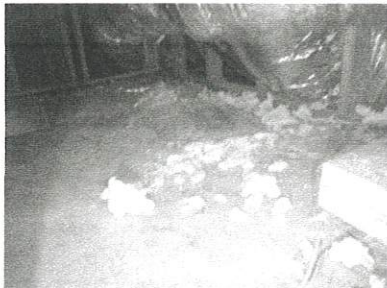
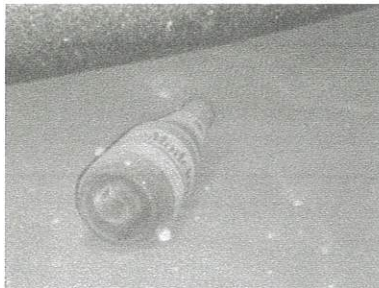
The attic(s) is insulated with spray foam that is applied to the underside of the roof decking. This is method of insulation encapsulates the attic space and HVAC systems in the thermal envelope of the structure and achieves a higher energy efficiency for the structure. One unique characteristic of this method is that the attics are not ventilated as in conventional construction. Since the roof structure, decking, and roof surface penetrations are not visible, it is unknown what, if any, deficiencies might exist.

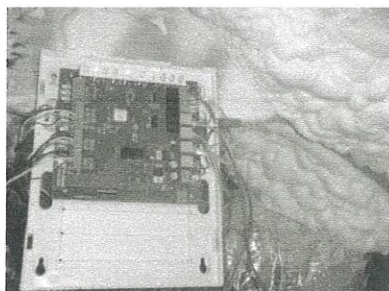
NOTE: The system is equipped with a fresh air intake system.

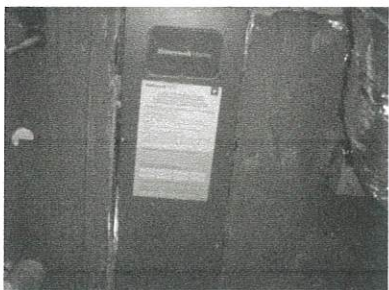
NOTE: This system is a three zoned single system. There are three thermostats, one for each level, and one single HVAC unit. Any or all thermostats are capable of making a demand on the system and initiating operation. This avoids having large temperature differences between levels with only one system by directing the airflow to any or all zones depending upon demand. This is achieved through the use of a mechanical damper that opens and closes in order to direct air flow to any or all zones of the house.

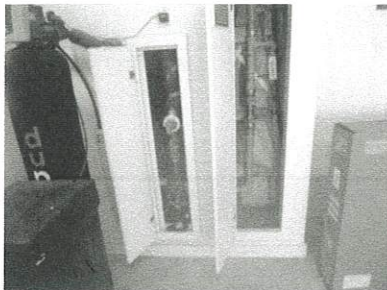
**Note:** The water meter, home owner shut off valve, and pressure reducing valve are located in the garage.
